Monitoring Data Record

Project Title: R-2231CB (US 220 Bypass) COE Action ID: 199400590
 Stream Name: UT to Big Mountain Creek (Site 6) DWQ Number: 000874
 City, County and other Location Information: Montgomery County, US 220 Bypass (Station 268+00 LT.

Monitoring Year: (4) of 5

UT Big Mountain Creek (Site 6)

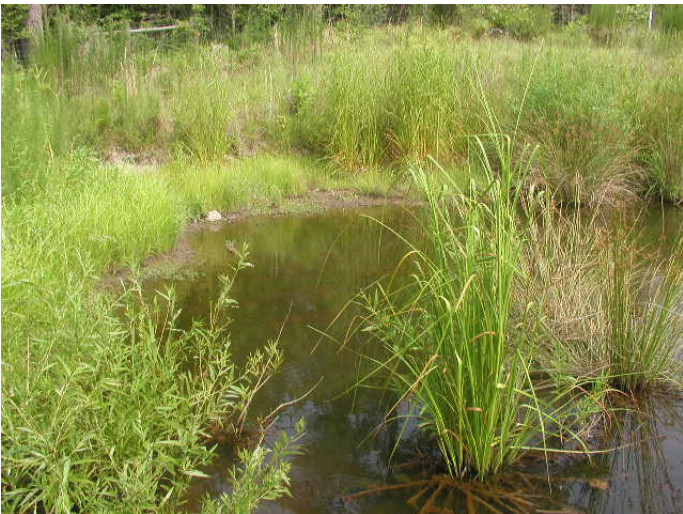
Photo Point #3 (Upstream)

The stream relocation is stabilized for the 2010 evaluation. The beaver dam noted during the 2009 evaluation downstream of Photo Point #3 has been breached and water is passing through at time of monitoring. NCDOT will continue to monitor this stream relocation.

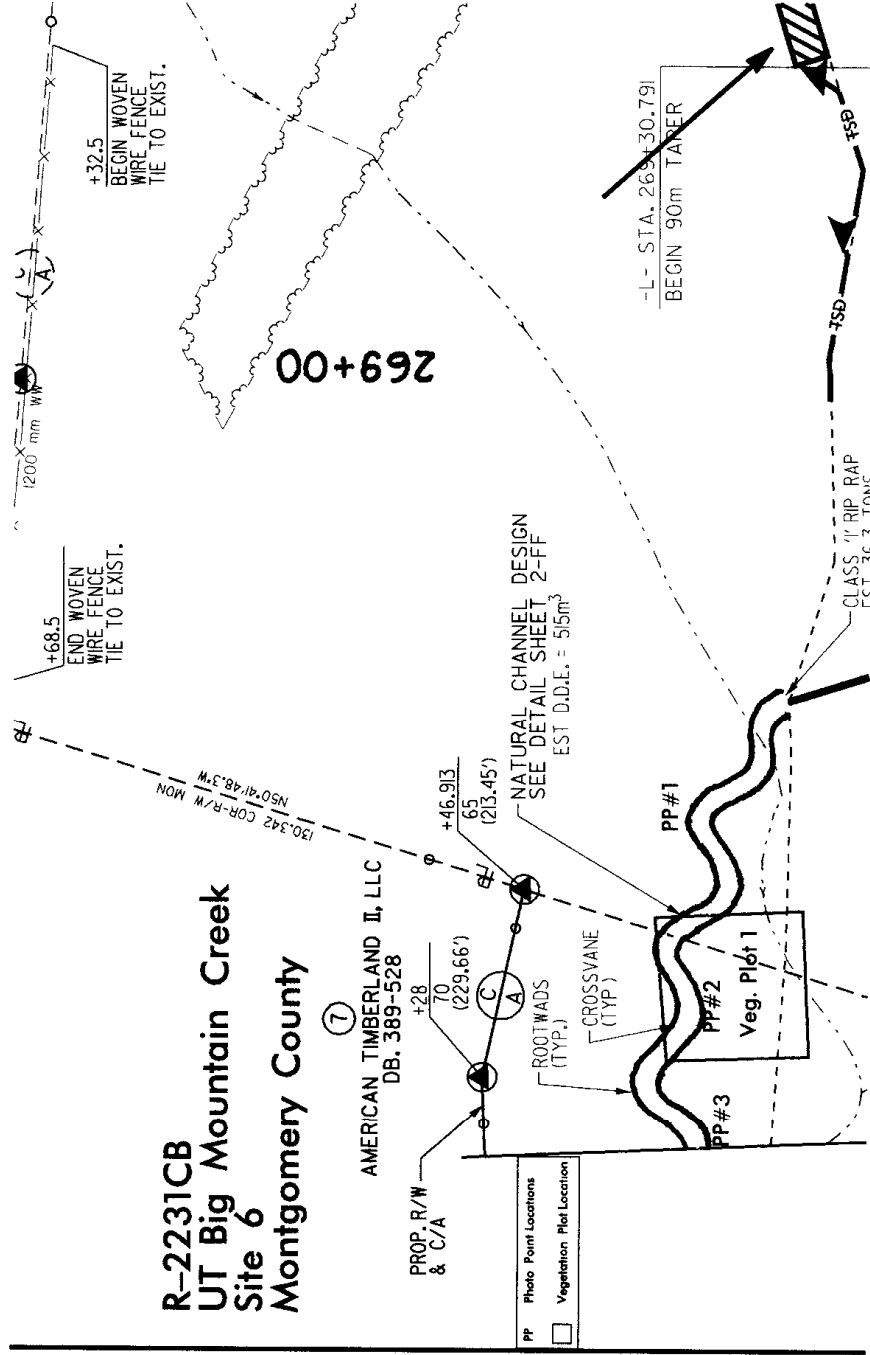
R-2231CB UT Big Mountain Creek Site 6 Montgomery County

PP Photo Point Locations
Vegetation Plot Location
